# RH 用耐火物の評価方法

## Evaluation of the Refractories for Application to the RH Degasser

## 冨田雄也, 田中雅人, 平 初雄

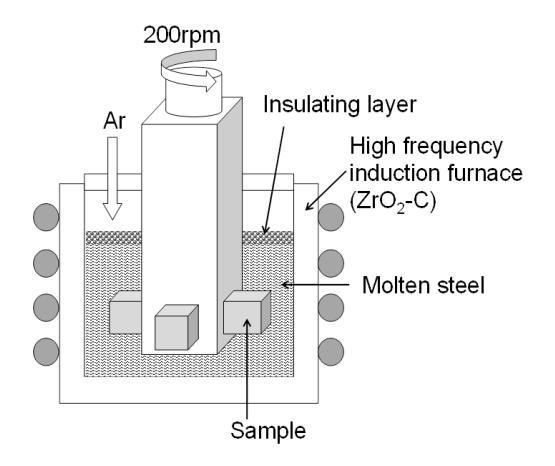
溶鋼中の酸化物による耐火物の損耗形態を過去に 古賀らが実施した溶鋼中で耐火物サンプルを高速回転 させる溶鋼撹拌試験法<sup>2)</sup>により評価した。Fig.1 に今回 の試験装置及び溶鋼撹拌用試験体の模式図を示す。

# Fig.1 Schematic illustration of the erosion test in the molten steel

Erosion resistance of refractories against oxides in molten steel has been evaluated by rotating samples at high speed in the molten steel.<sup>2)</sup> Schematic illustration of the erosion test system is shown in **Fig.1**.

A high frequency induction furnace (50kW, 2.3 to 3.1kHz) in which a zirconia crucible (inner diameter 130mm, depth 195mm) was inserted was used for melting the steel. Approximately 10kg of low-carbon steel (C: 0.11%, Si: 0.22%, Mn: 0.55%) was heated to 1600°C and kept at the temperature in Ar flow in the crucible. After that, each Al and Si in an amount of 0.4% in terms of outer percentage was added into the molten steel. These

溶鋼撹拌用試験体は、ジルコニア質の角柱耐火物(40×40×180mm)の先端部に評価用試料(20×20×25mm)を90°ピッチで円周4方向に取り付けた。溶鋼 撹拌試験は、作製した溶鋼撹拌用試験体を溶鋼直上 で5分間保持した後に溶鋼中に浸漬し、200rpmの回 転速度(周速1.0m/sec)で120min間連続回転させ た。本法での撹拌は、溶鋼中における酸化物の懸濁 化および溶鋼流速下での耐火物と酸化物の反応促進 のために実施している。試験中は、炉蓋と鋼浴部の間 1NL/minのArガスを流し、試験途中の鋼中酸素濃度 の上昇が極力抑制されるようにした。同時に、溶鋼温度 は1600~1650℃の範囲になるように管理した。

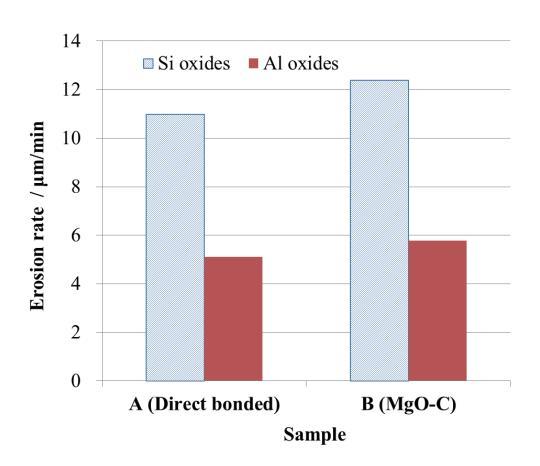
**Fig.2**に Si, Al 酸化物での溶鋼撹拌試験の結果を示 す。いずれの酸化物に対しても耐食性は、マグカーボン れんがと比較して、ダイレクトボンドのマグクロれんがが耐 食性が優れる結果となった。また、各酸化物に対する損 耗速度を比較すると Al 酸化物による損耗速度は、Si 酸 化物による損耗速度と比較して小さいことが分かった。

# Fig.2 Results of the erosion test for both samples in the molten steel against both types of oxides.

**Fig.2** shows the results of the molten steel stirring test of the samples A and B for both Si and Al oxides. The direct-bonded magnesia-chrome brick (sample A) showed

superior erosion resistance against both oxides to the magnesia-carbon brick (sample B). The erosion rate of the both samples by the Al oxides was lower than that by the Si oxides.

The amount of wear of refractories by both Si and Al oxides in the molten steel was counted in both samples of magnesia-chrome brick (A) and magnesia-carbon brick (B). The wear of the sample B was larger than the sample A for both oxides. In addition, the wear rate of two samples by the Si oxide was larger than that by Al oxide.

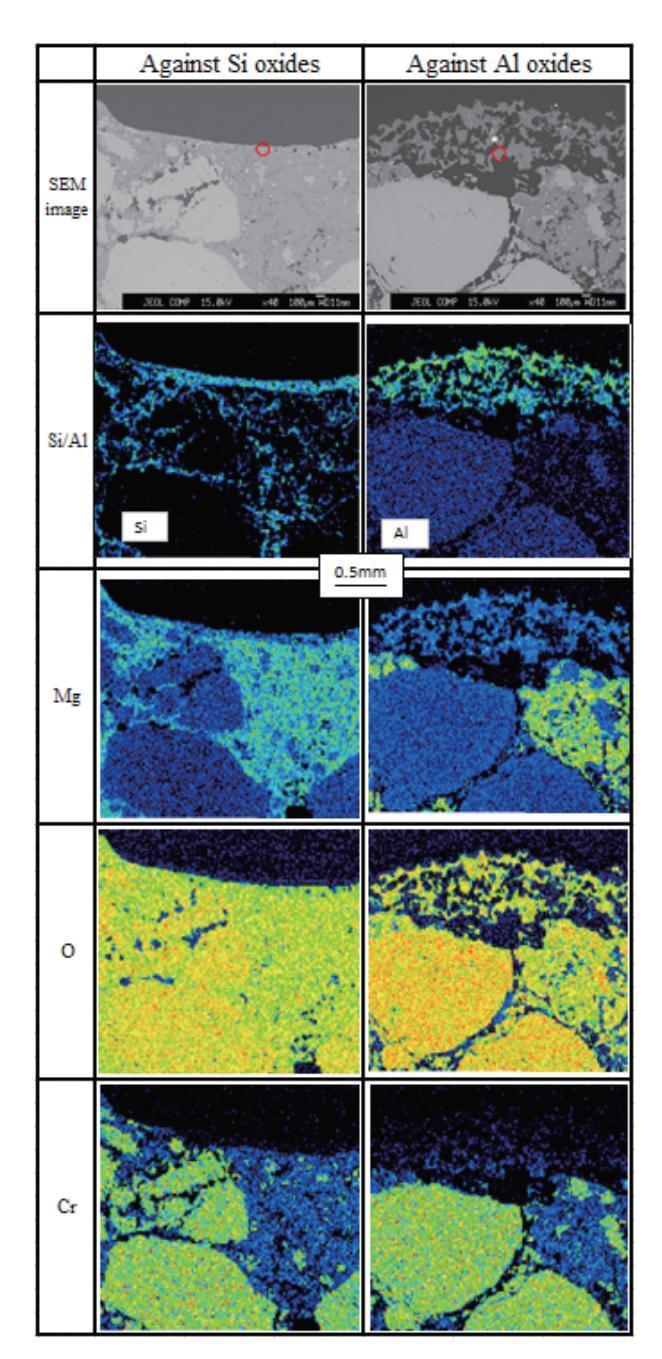
ダイレクトボンドのマグクロれんが(A)の溶鋼撹拌試 験後の稼働面状態を EPMA により観察した。**Fig.3**は 各鋼中酸化物による侵食試験後の稼働面状態を示して いる。Si 酸化物では稼働面には、MgO-SiO<sub>2</sub> 系の反 応層が観察され、さらにれんが内部へ SiO<sub>2</sub> が侵入して いることが分かる。Al 酸化物では、稼働面には MgO-Al<sub>2</sub>O<sub>3</sub> 系の 500  $\mu$  m 程度の反応層が形成されているこ とが分かる。Cr<sub>2</sub>O<sub>3</sub> は反応層にほとんど含まれておらず、 ほぼ粒の原型を保持していた。

Fig.3 EPMA analysis of direct bonded brick's hot surface tested in Si oxides and Al oxides in molten steel.

The hot surface of the direct-bonded magnesiachrome brick after the molten steel stirring test was observed and analyzed by the EPMA. **Fig.3** compares the state of the hot surface after the test by both oxides in the molten steel. In the case of Si oxides, MgO-SiO<sub>2</sub>

以上の結果から分かるように,いずれの耐火物も鋼 中の酸化物と反応して反応層を形成することが分かっ た。この形成された反応層が耐火物の溶損に影響を与 えると考え,この反応層の調査を行った。**Table 3** に Si based reaction layer was formed on the hot surface, and  $SiO_2$  penetrated into the brick. In the case of Al oxides, MgO-Al<sub>2</sub>O<sub>3</sub> based reaction layer with 0.5mm thickness was formed in the hot surface. Chromium oxide hardly contained in the reaction layer, and it retained almost the original shape of the grain.

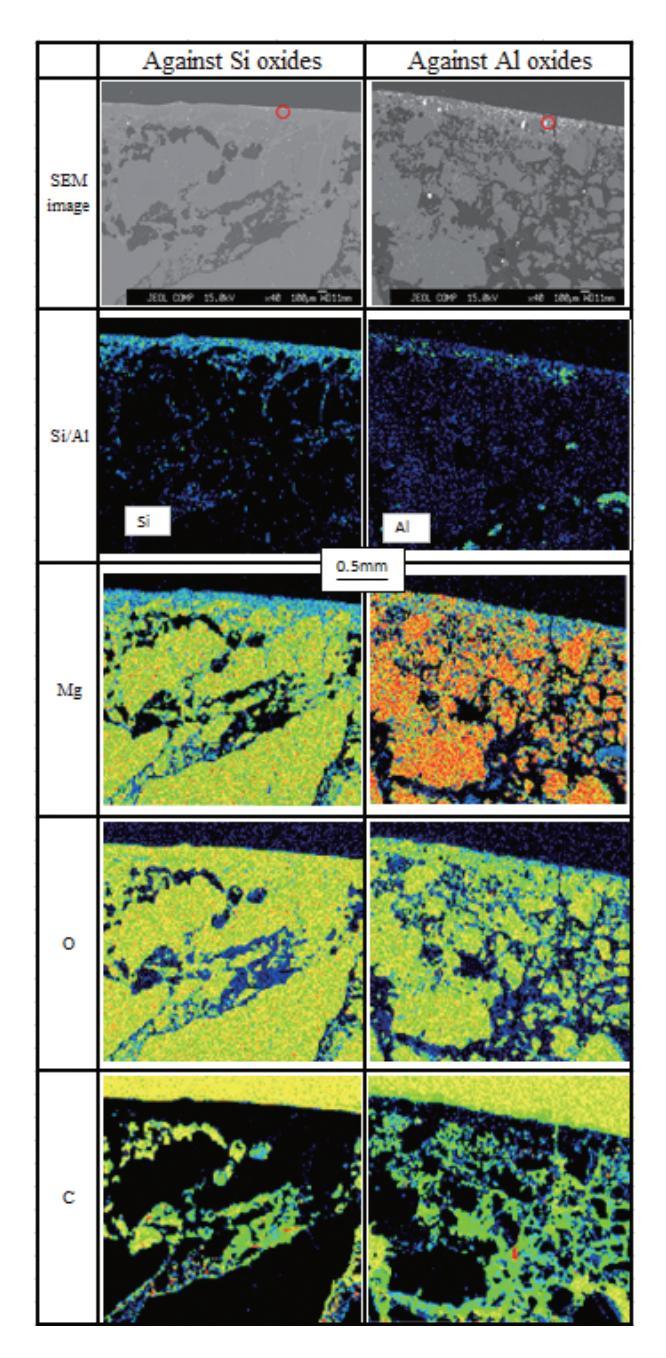
マグカーボンれんが(B)の溶鋼撹拌試験後の稼働 面状態について EPMA により観察した。Fig.4 は、各 鋼中酸化物による侵食試験後の稼働面状態を示してい る。稼働面には、炭素を含まない MgO-SiO<sub>2</sub> 系の反応 層が観察された。一方、マグクロれんがで見られた、れ んが内部へ SiO<sub>2</sub> の侵入は抑制されていることが分か

Fig.4 EPMA analysis of MgO-C brick's hot surface tested in Si oxides and Al oxides in molten steel.

る。Al酸化物による試験後の稼働面には炭素を含まない MgO-Al<sub>2</sub>O<sub>3</sub>系の反応層が形成されており、Al<sub>2</sub>O<sub>3</sub>の侵入はほとんど見られないことが分かる。

The hot surface of the magnesia-carbon brick after the test was also observed and analyzed by the EPMA. **Fig.4** shows the state of the hot surface after the erosion test by both oxides in the molten steel. In the case of Si oxides, MgO-SiO<sub>2</sub> based reaction layer containing no carbon was formed on the hot surface. On the other hands, the penetration of SiO<sub>2</sub> into the brick which was observed in the case of magnesia-chrome brick was suppressed. In the case of Al oxides, MgO-Al<sub>2</sub>O<sub>3</sub> based reaction layer containing no carbon was also formed on the hot surface. The penetration of Al<sub>2</sub>O<sub>3</sub> into the brick was not observed. **3-2-3 Chemical composition of the reaction layer**

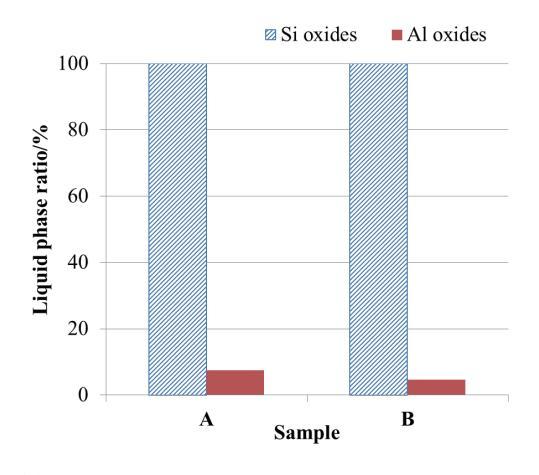
いずれのれんがも,稼働面に鋼中の酸化物と反応したと考えられる反応層が形成されていた。反応層の液相率を先程の分析値から熱力学計算ソフト(FactSage)で1650℃の温度で算出した結果をFig.5に示す。Si酸化物で形成された反応層の液相率は,100%となっており,稼働面で形成された反応層は溶出しやすいことが考えられる。一方,AI酸化物で形成された反応層は,液相率が10%未満となっており,Si酸化物によって形成された反応層と比較して溶出しがたいことが考えられる。このようにSi酸化物は,AI酸化物と比較して稼働面に形成される反応層の液相率が高かったため,溶損速度が大きくなったことが考えられる。

Fig.5 Liquid phase ratio of the reaction layer.

Both refractories were considered to react with the oxide in the molten steel and formed a reaction layer at the hot surface. Based on the analytical results of the reaction layer formed at the hot surface, shown in the **Tables 3** and **4**, **Fig.5** shows the results of calculation for both samples A and B against Si and Al oxides, respectively. The

liquid phase ratio at the surface contacted to the molten steel was calculated by the software (FactSage) assuming the temperature of 1650 °C. The liquid phase ratio of the reaction layer formed by the Si oxides was 100% for both samples A and B, so that the formation layer at the hot surface enhanced the erosion (wear-off) of the samples. On the other hand, the liquid phase ratio of the reaction layer formed by the Al oxides is less than 10% for both samples. It means that the reaction layer formed by the Al oxides has higher resistance to the erosion than that by the Si oxides. Since the liquid phase ratio of the reaction layer formed by the Si oxides at the hot surface was higher than by the Al oxides, it was conceivable that the wear rate was increased.

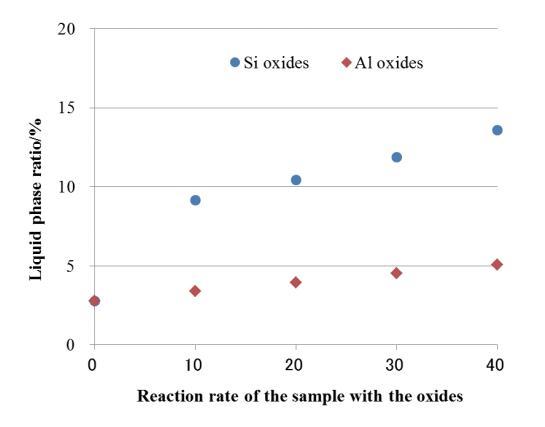
マグクロれんがの鋼中酸化物による損耗形態は,まず, マグクロれんがと鋼中の酸化物が接触して反応層を形 成することが考えられる。そこで,マグクロれんがが鋼中 の酸化物と反応した場合の液相率を算出した。今回の 計算では,マグクロれんがの成分が均一であると仮定し, その耐火物成分と鋼中の酸化物が,0~40%まで反応 した場合の液相率を算出した。Fig.6に1650℃で各鋼

## Fig.6 Analytical relation between the liquid phase ratio and the reaction rate of the magnesiachrome brick with both oxides.

is plotted against the reaction rate of the brick component and the oxides in the steel at 1650 °C with the range from 0 to 40% in **Fig.6**. It is understood that the liquid phase ratio is very low when the reaction proceeds with the Al oxide compared to the Si oxide. The higher liquid phase ratio in the Si oxide is considered to enhance the higher rate of erosion.

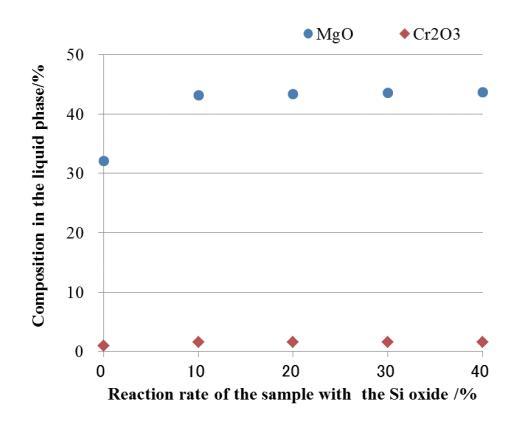
Fig 7 に Si 酸化物によって生成した液相中のマグネ シアとクロムの割合を算出した結果を示す。マグネシア はクロムと比較して、液相中に含まれる割合が非常に高 いことが分かる。この計算結果と、反応層の分析結果 がマグネシアとシリカ主体であったことから、マグクロれん がは、Si 酸化物と液相を生成しやすいマグネシアから溶 出することによって、損耗が進行したと考えられる。

## Fig.7 Analytical relation between the composition in the liquid phase and the relation rate of the magnesia-chrome brick with the Si oxide.

**Fig.7** shows the relation between the calculated compositions of the magnesia and the chromium oxide in the liquid phase and the reaction rate of the sample with the Si oxide. Comparing both magnesia and chromium oxide, it is found that the proportion of the magnesia contained in the liquid phase is extremely high. From this calculation result and analysis result of the reaction layer shown in the **Table 3**, the major component of the layer was MgO and SiO<sub>2</sub>. It is considered that the wear of the magnesia-chrome brick is controlled by the elution of the MgO which is likely to generate the liquid phase by the Si oxides.

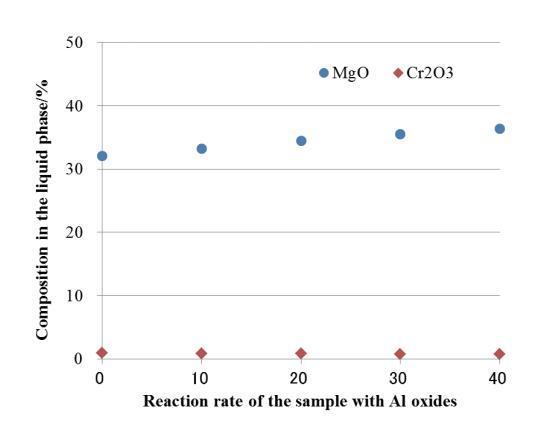
Fig 8に Al 酸化物によって生成した液相中のマグ ネシアとクロムの割合を算出した結果を示す。マグネシ アはクロムと比較して, Si 酸化物と同様に液相中に含ま れる割合が非常に高いことが分かる。この計算結果と, 反応層の分析結果がマグネシアとアルミナ主体であった ことから,マグクロれんがは, Al 酸化物と液相を生成し やすいマグネシアから溶出することによって,損耗が進行 したと考えられる。

## Fig.8 Analytical relation between the composition in the liquid phase and the reaction rate of the magnesia-chrome brick with the Al oxides.

**Fig.8** shows the relation between the calculated composition of the magnesia and the chromium oxide in the liquid phase and the reaction rate of the sample with the Al oxide. Comparing both magnesia and chromium oxide, it is found that the proportion of magnesia contained in the liquid phase is very high. From this calculation result and analysis result of the reaction layer shown in the Table 4, the major component of the layer was MgO and  $Al_2O_3$ . It is considered that the wear of the magnesia-chrome brick is controlled again by the elution of the MgO which is likely to generate the liquid phase by the Al oxides.
